MODIFICATION OF PROBE ASSEMBLIES

This report describes the mechanical modifications made to the scintillation counter probe developed on program A075 in an effort to increase its resistance to severe handling. The results of vibration testing of the modified probe and the electronic unit associated with it.

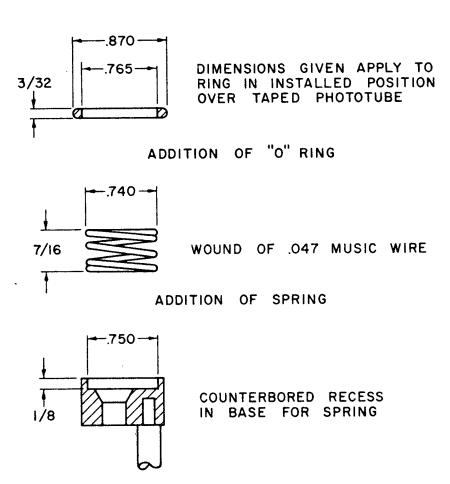
MODIFICATION OF BASE

"HEVI-MET" AT PHOTOMULTIPLIER END SHORTENED .010
.010 PLYABOND PAPER WASHER CEMENTED ON

- 1. Centered the hevi-metal shield and collimator in the probe housing by the use of metal sleeves, and rigidly fastened the hevi-metal to the housing with two screws.
- 2. Floated the photomultiplier tube inside of the housing utilizing a part of the sleeve that centers the hevi-metal and a ground down "0" ring for centering the tube.
- 3. Spring loaded the photomultiplier tube with a helical spring for proper tension.
- 4. A 0.010 inch washer, made of paper, was inserted between the "hevi-met" collimator and photomultiplier tube face (cathode) to prevent formation of spurious pulses at the anode. The "hevi-met" was shortened 0.010 inch to maintain the same over-all length when the washer was cemented into place with plyabond rubber adhesive.
